Westwind Mines
Corkscrew Road
Follow Up Inspection
08-10-2007(A)

Job: Re-inspect mine for storage containment system of used oil.

Westwind Mines
Corkscrew Road
Follow Up Inspection
8-10-2007 (B)

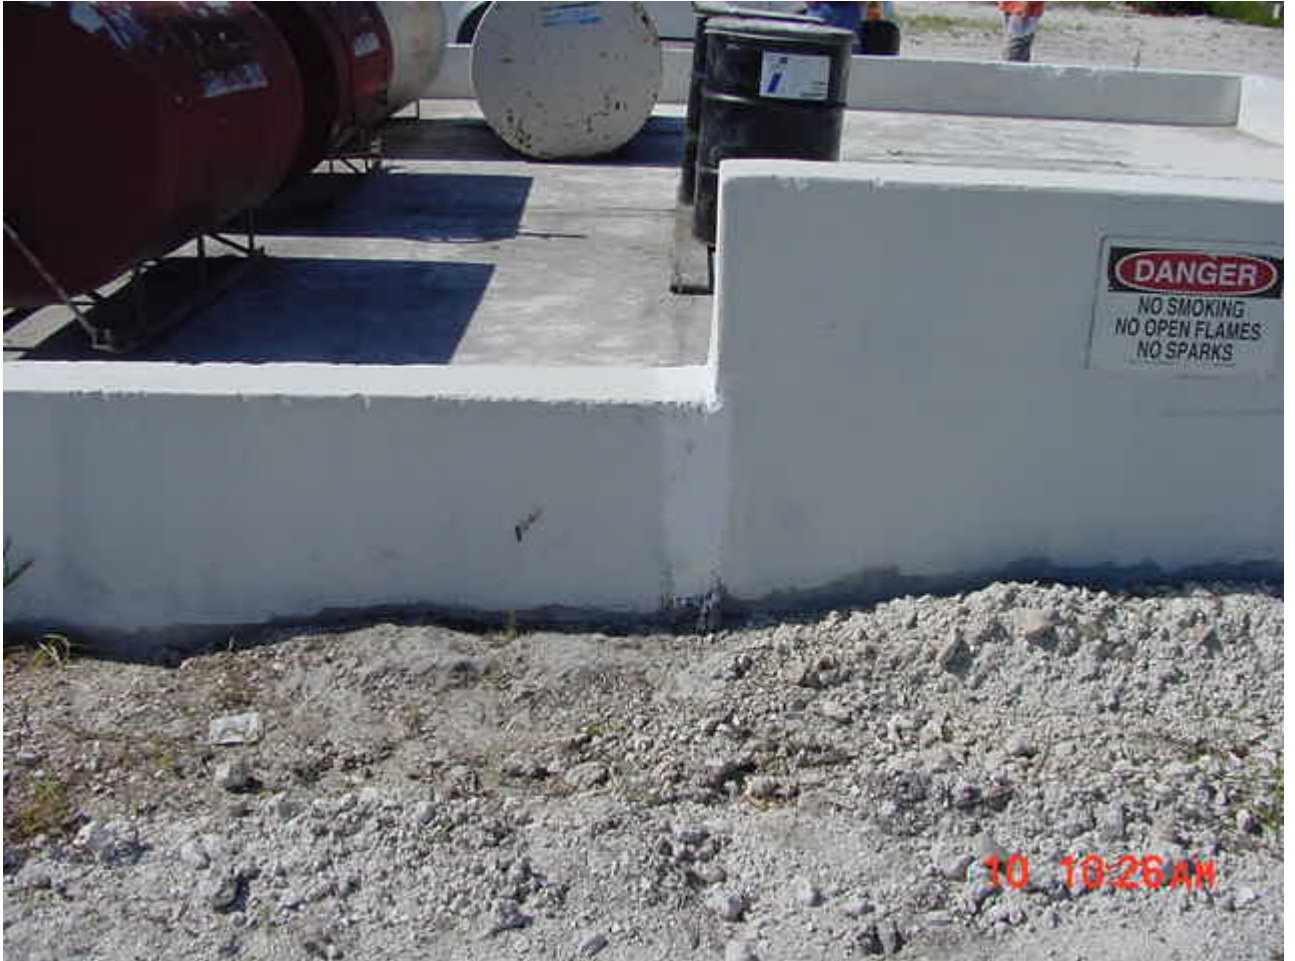
The paint line for the “sealer” does not extend past the floor/wall line. Not sure what type of material was used, but appears to be textured latex paint.

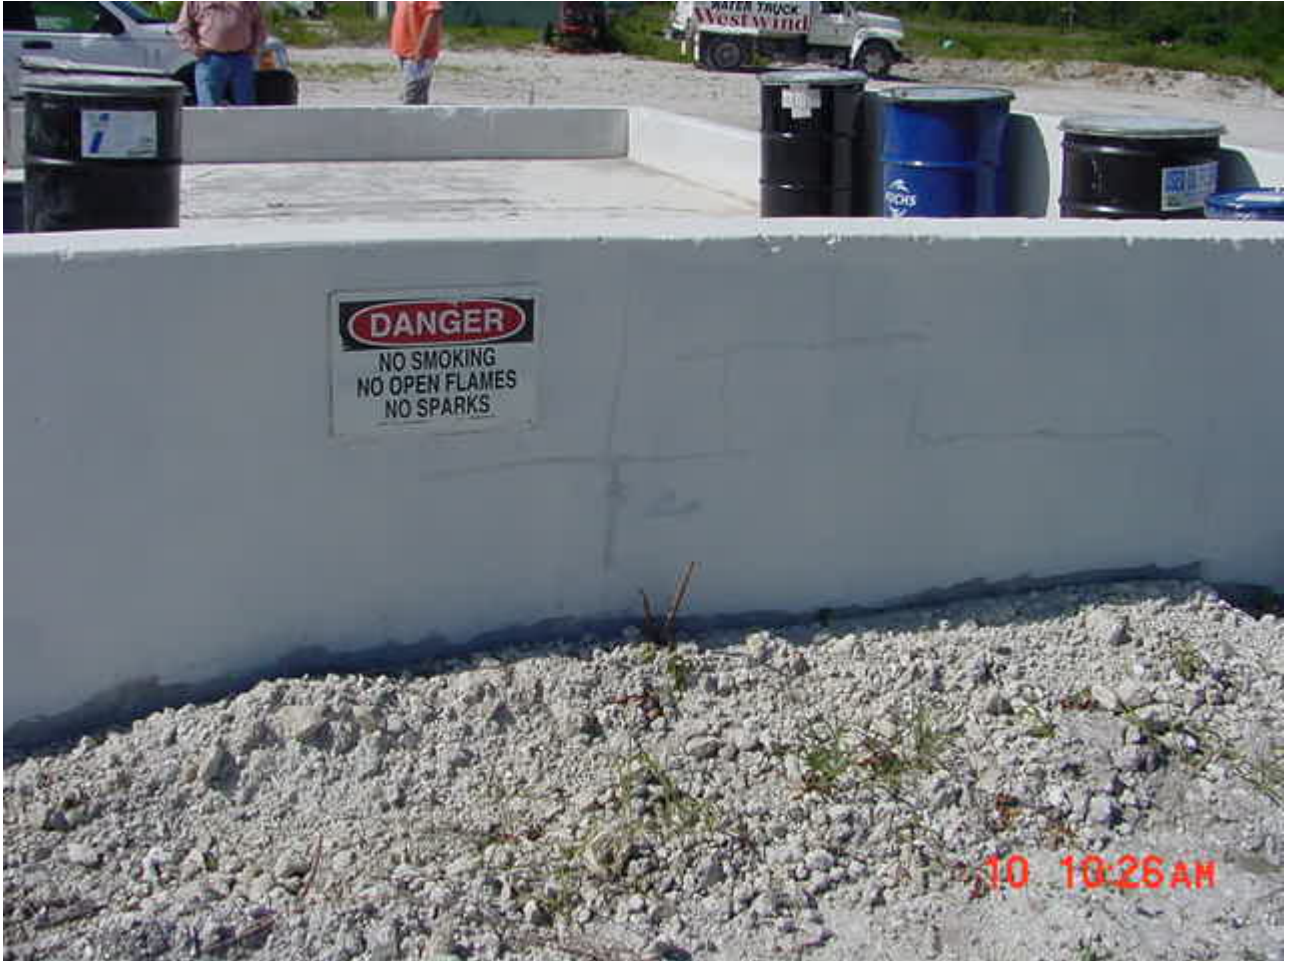
Block joint cracks still visible. Outside dirt line above floor elevation of containment system. The coating that was applied does not seal the joint crack between the floor and the wall. There is nothing to protect the system from weather.

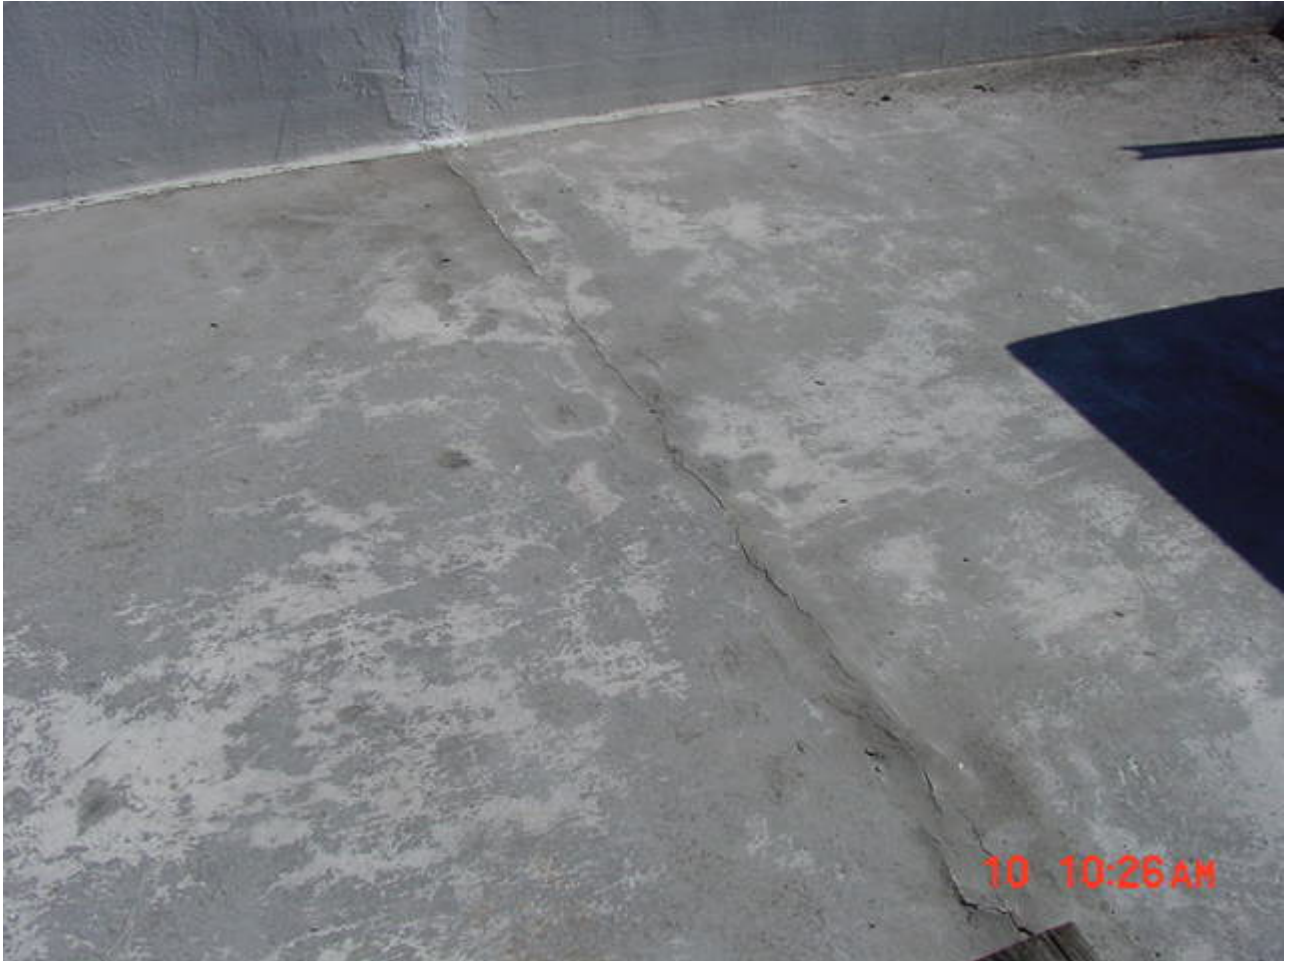
Floor cracks were not repaired and sealed. Entire floor sealant shows evidence of failure where ever there were floor joints.

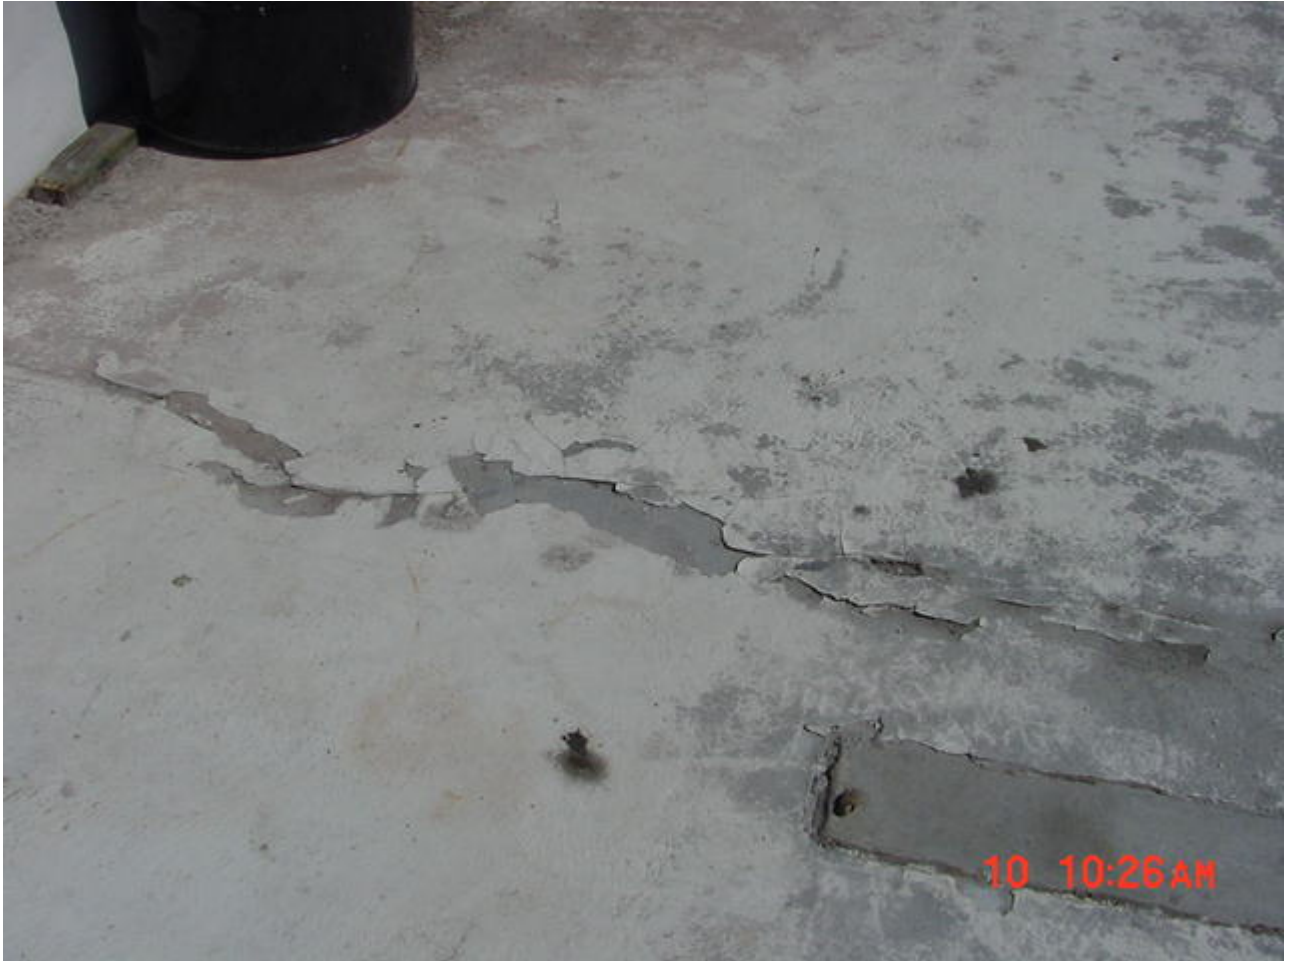
Floor sealant cracking and peeling off of floor and is not providing required protection.

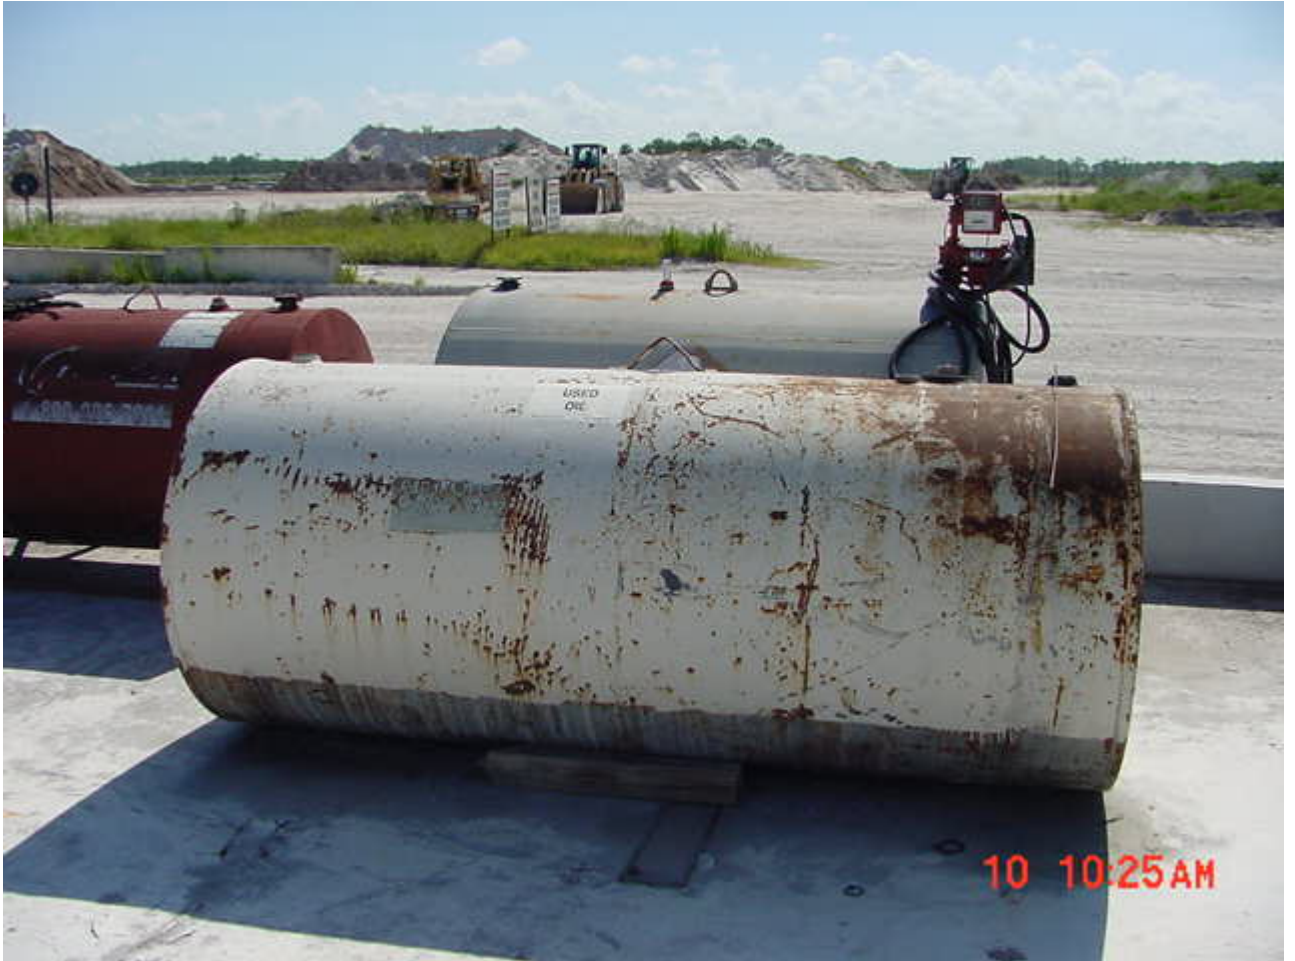
The used oil tank within the containment system that is not protected from the weather as required. Labeling of tank should be placed in all directions that emergency responders would approach in case of a fire.

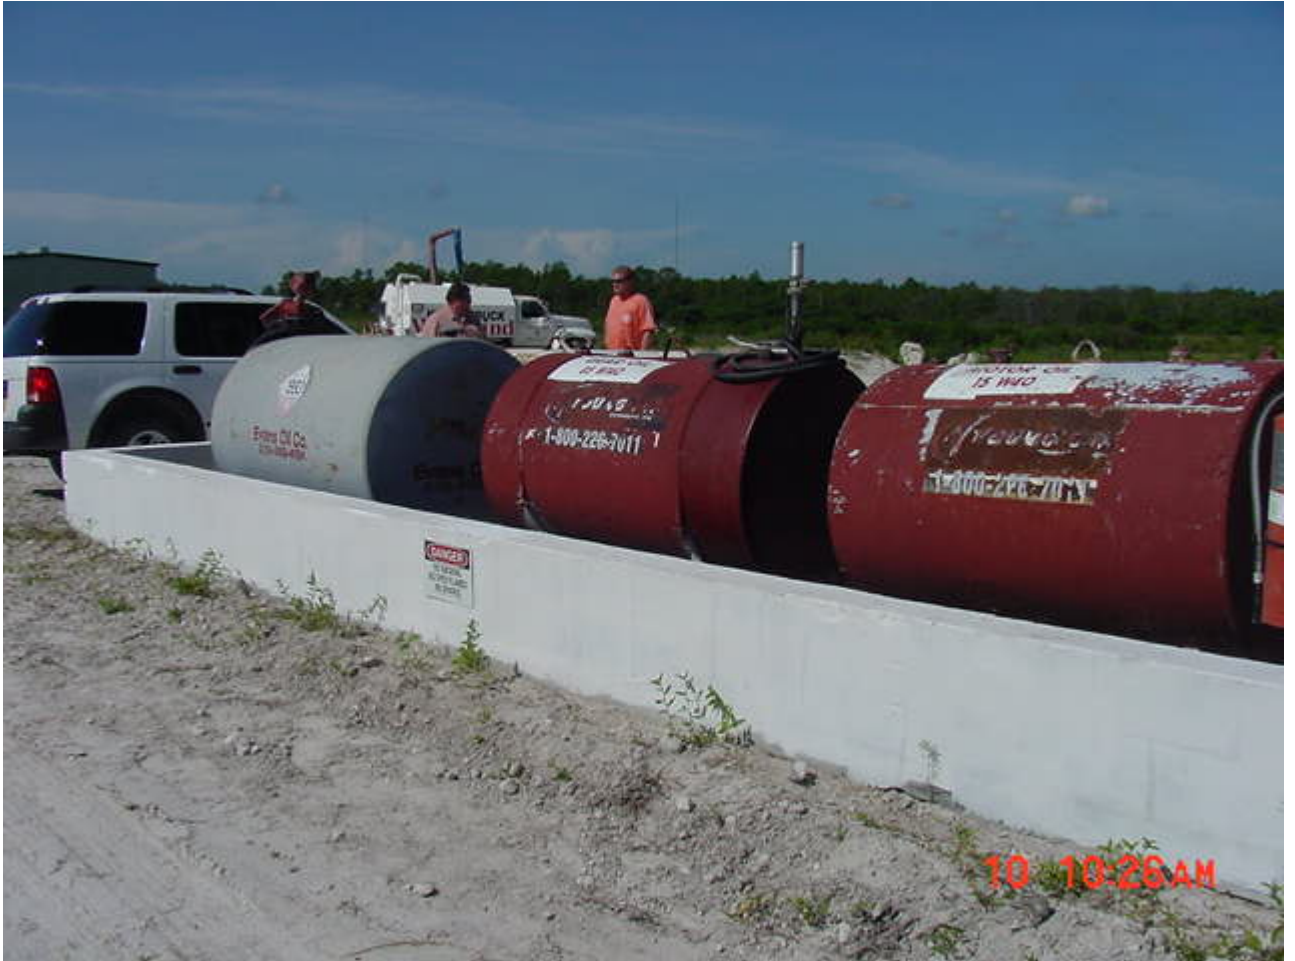
Other fuel tanks stored within containment system that holds the used oil tank. No roof over the containment system to protect from weather.

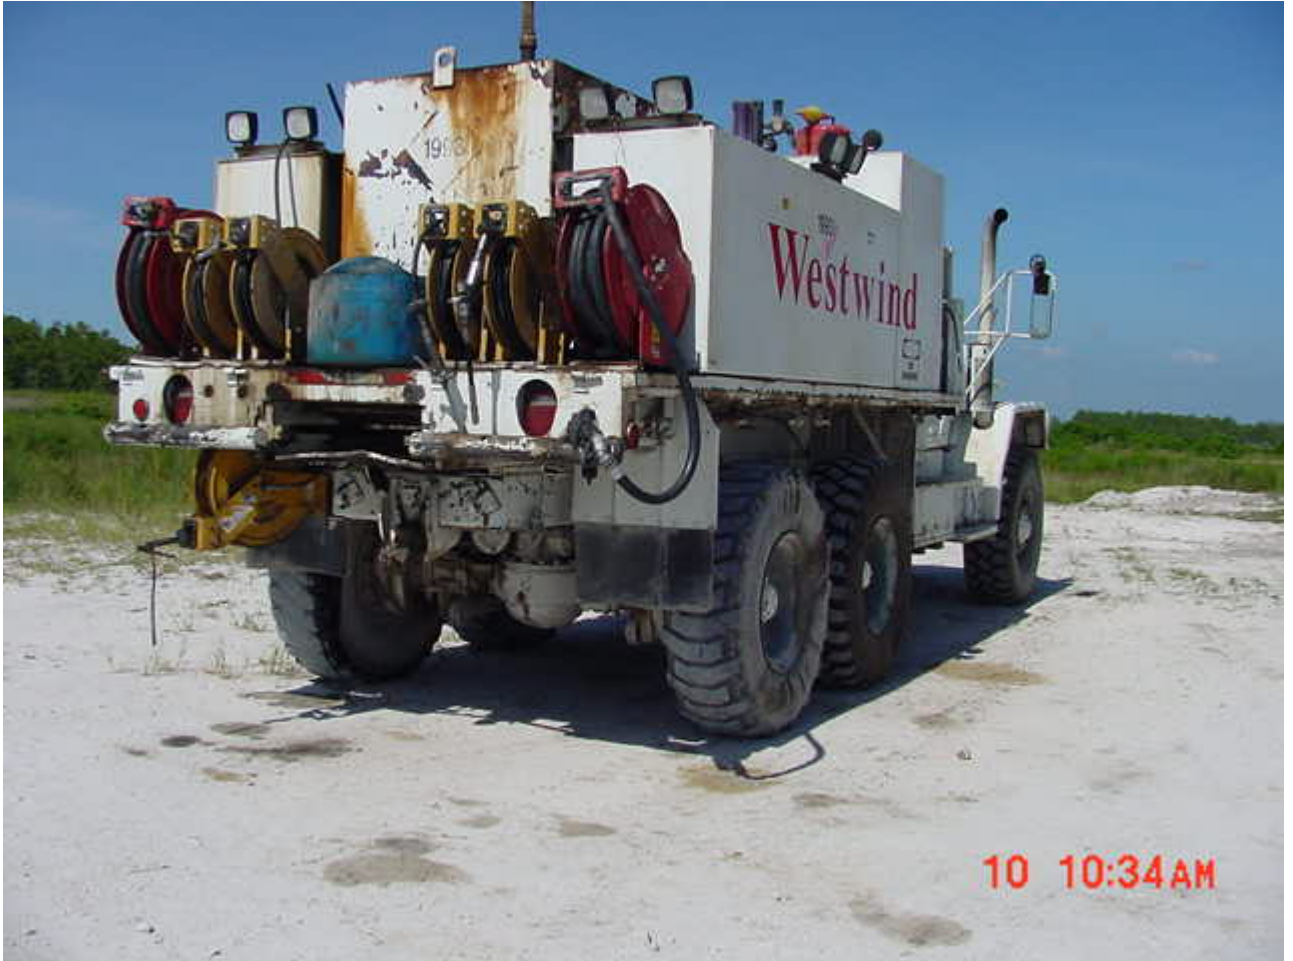
The mobile fueling truck utilized onsite is leaking. This operational equipment was referenced in the P2 Plan, for the renewal of the operational permit which had specific requirements to prevent leaks and discharges. This too is out of compliance with the mine's P2 plan and BMP's established to prevent petroleum discharges.

Fueling vehicle mentioned in Pollution Prevention Plan that was required for the renewal permit reveals leaks to soils. Plan required no leaks and prevention of discharge while fueling. Assumption was that the fueling vehicle would not be leaking on its' own.

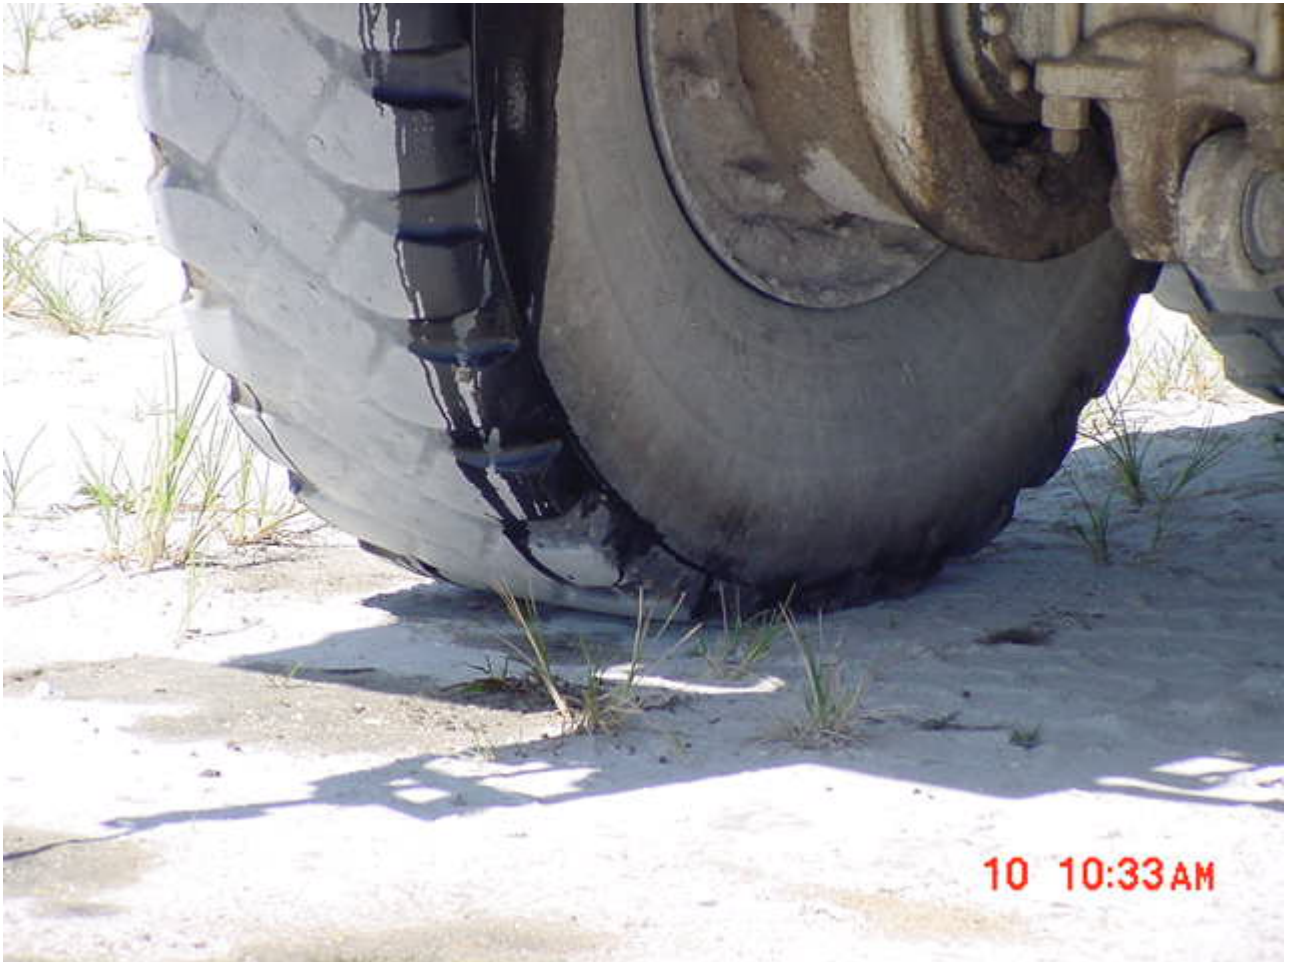
Evidence of one of the leak's from fueling vehicle running down the left rear tire onto the soils.

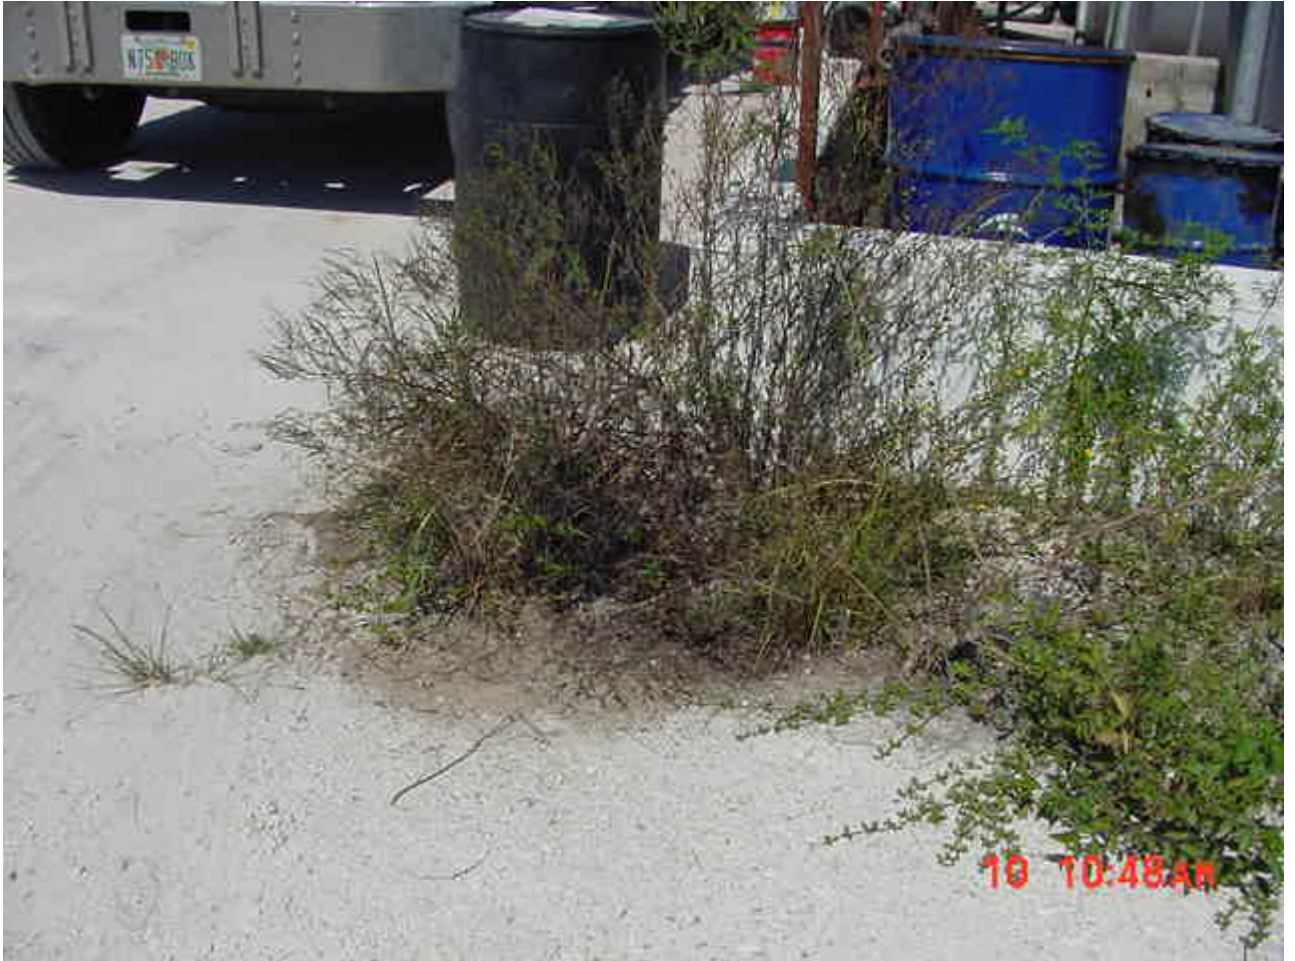
The S.E. corner of this containment system has evidence of petroleum discharge. The black drum contains industrial degreaser for heavy equipment. Not sure where waste water from this procedure is disposed.

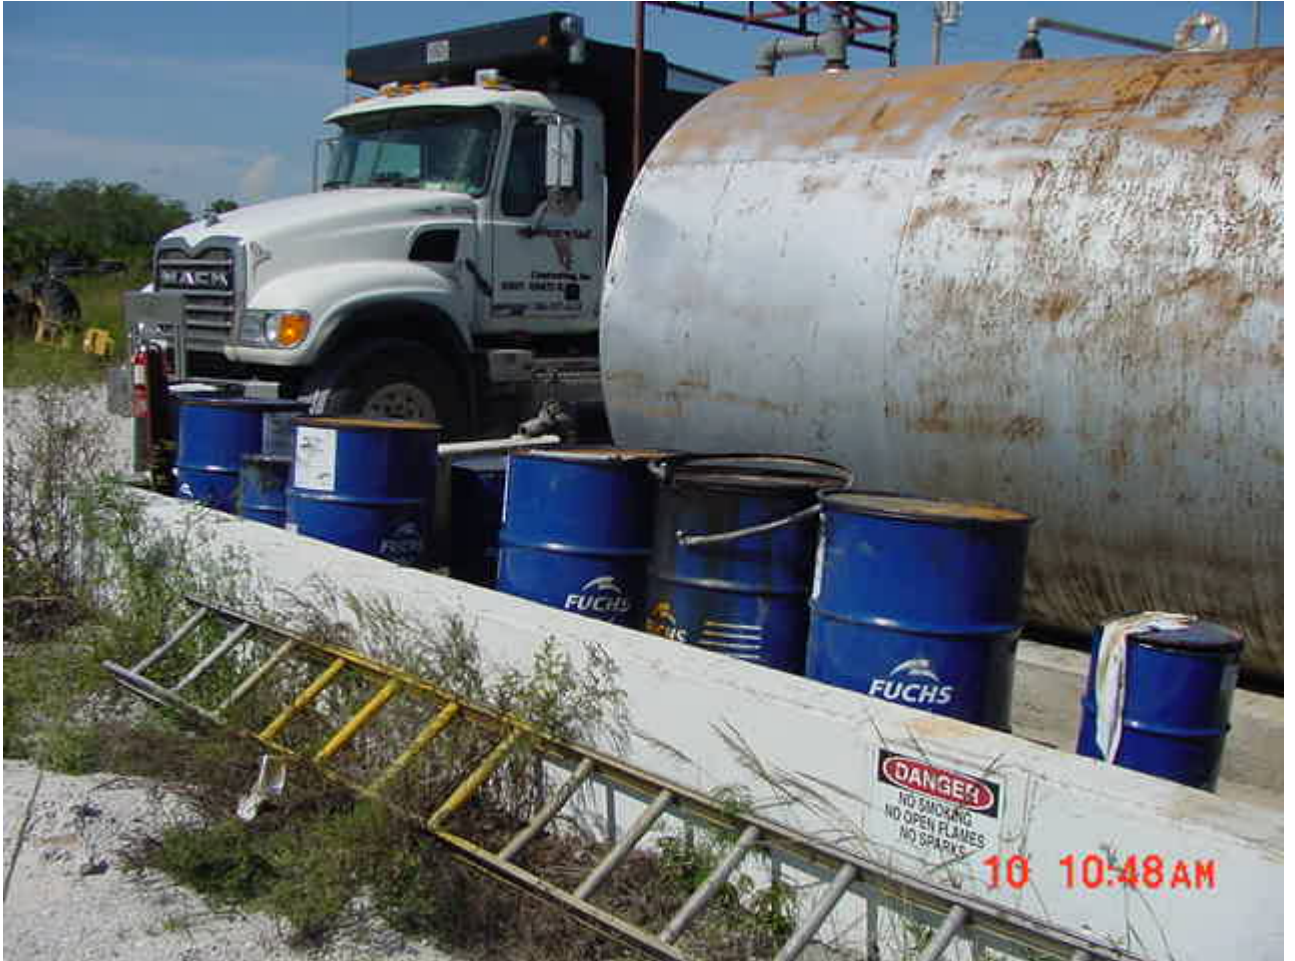
Under the ladder within the stressed vegetation is evidence of petroleum discharge along east wall of containment system.

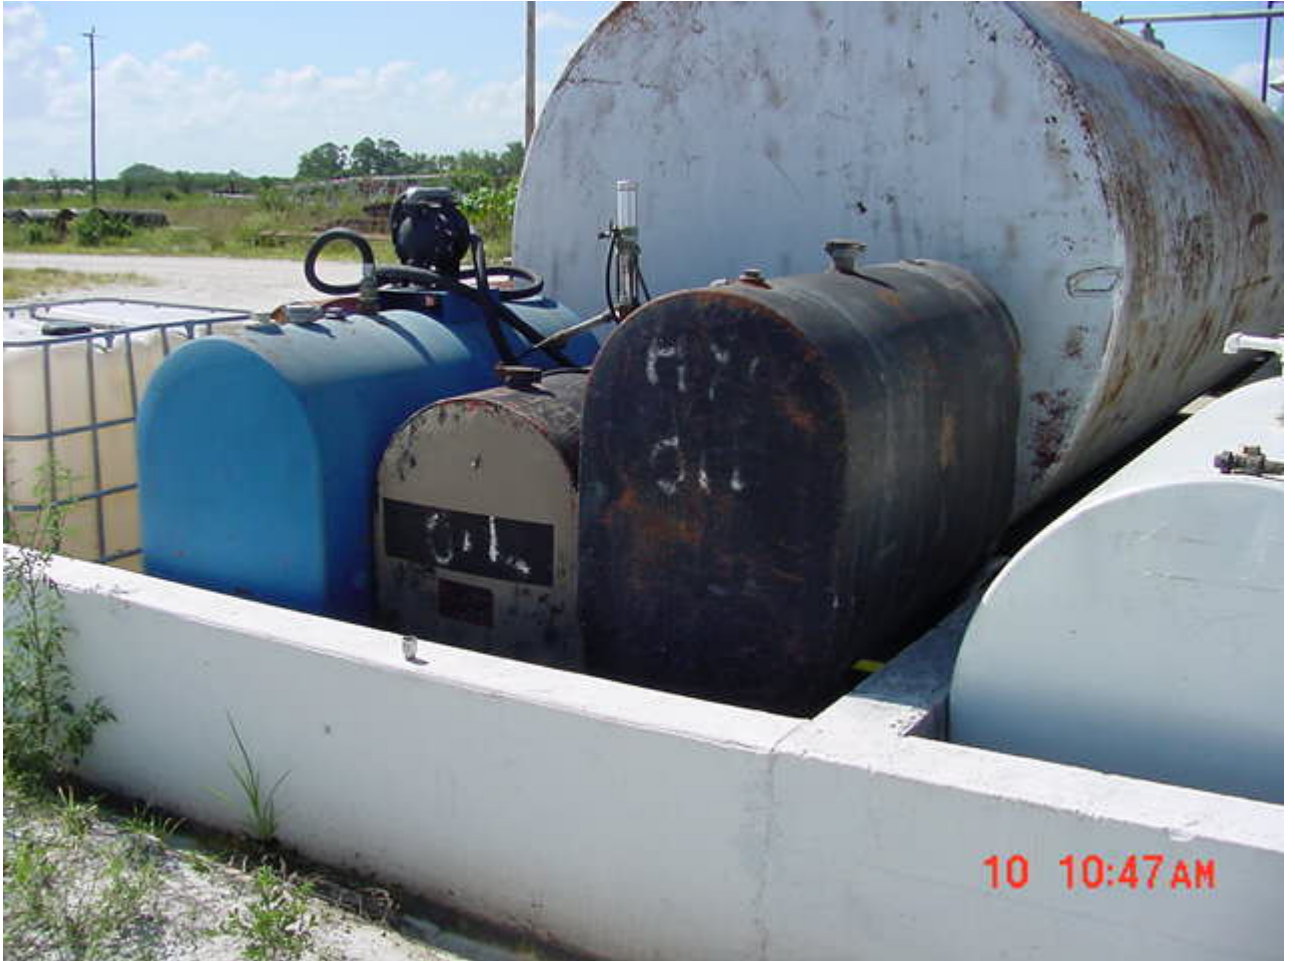
These tanks were previously in the containment system mentioned in part “A” of this report and documented in the previous report dated 12- -05 .

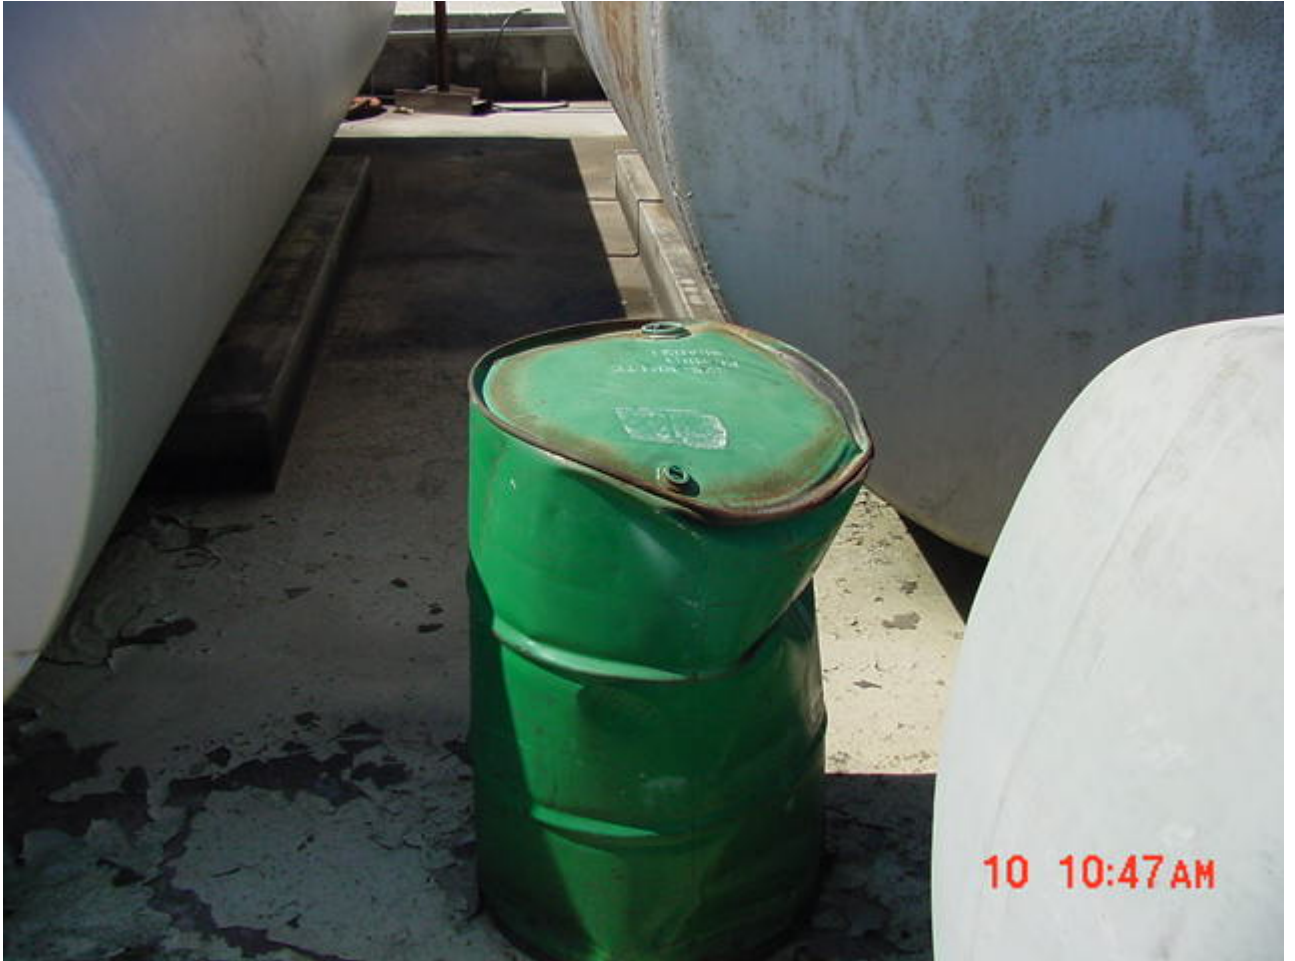
Most of containment system has evidence of petroleum discharges. A damaged barrel of unknown contents sits within containment system on the unsealed floor. System is not protected from the weather.

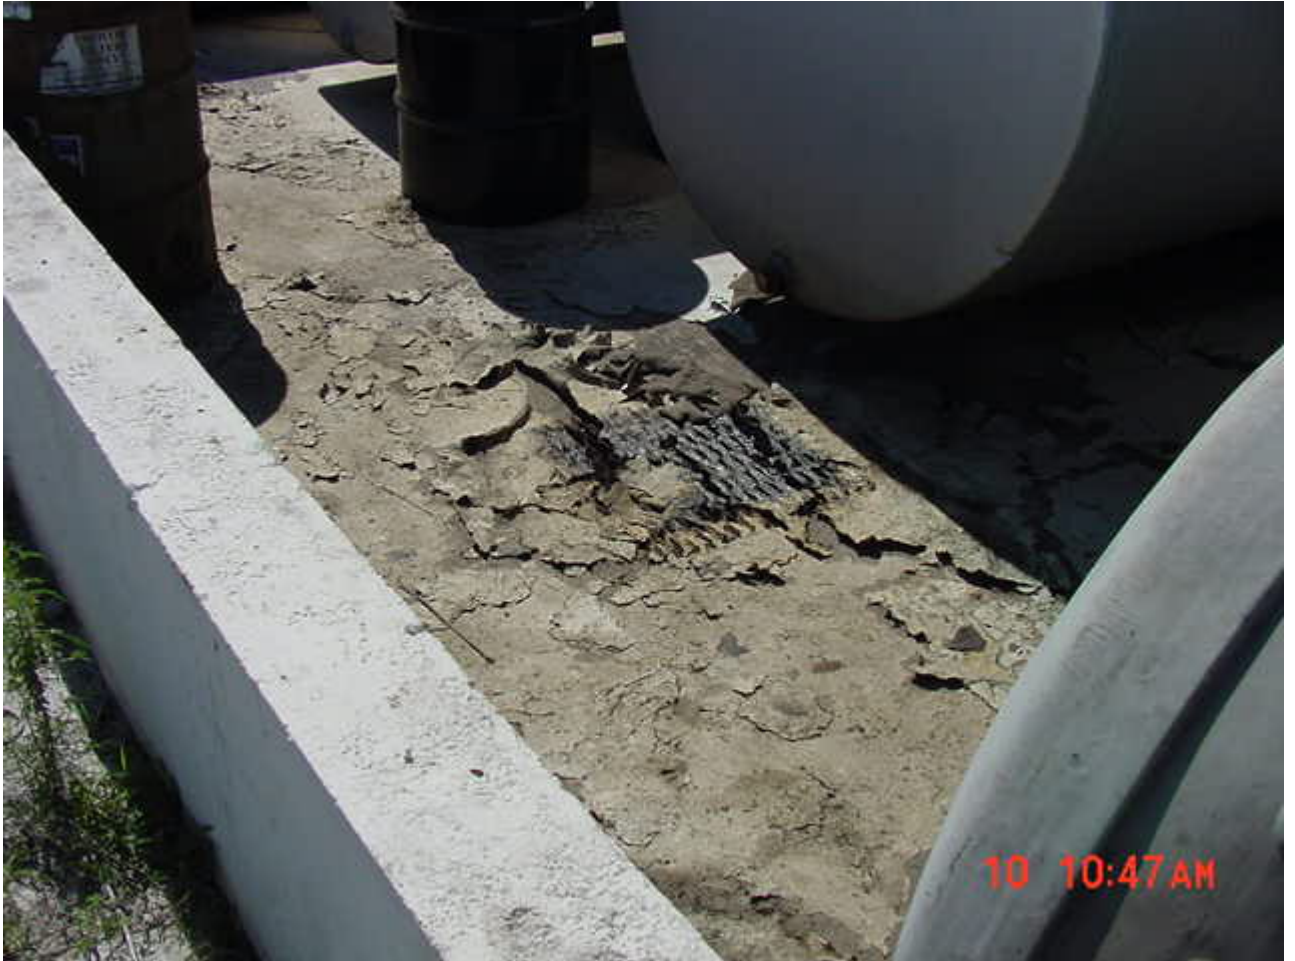
Drain within the containment system shows evidence of petroleum discharge. An algae mat possibly formed from diesel covers most of the containment system floor. Unknown where drain's end or where it goes.

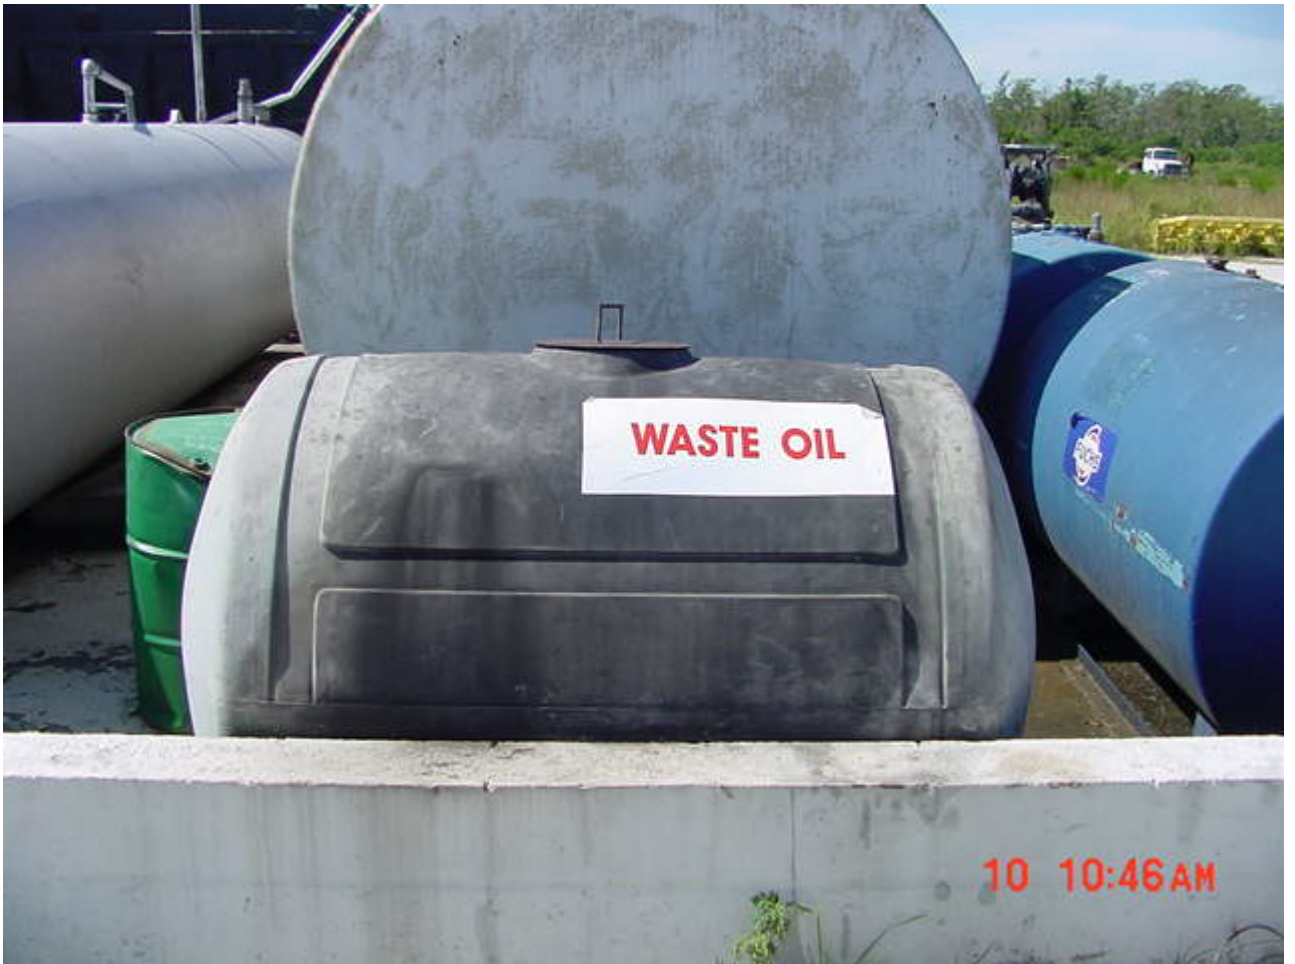
An improperly labeled tank of used oil within an unprotected from the weather, not properly sealed containment system.

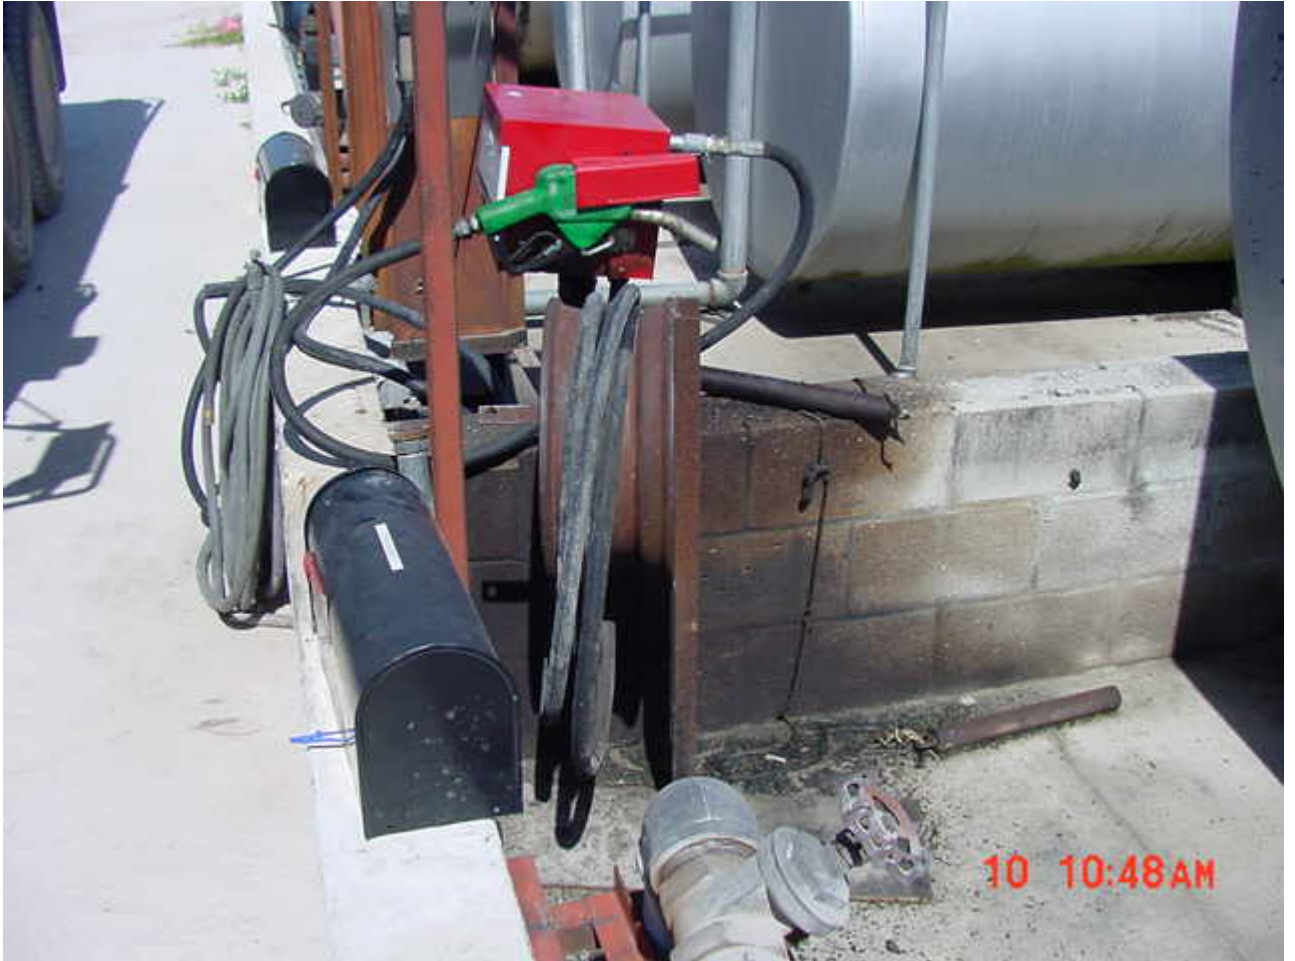
Fueling operation's which reveal sloppy use that contributes to rainwater contamination within containment system. Containment system is not properly sealed and has a drain with unknown ending.

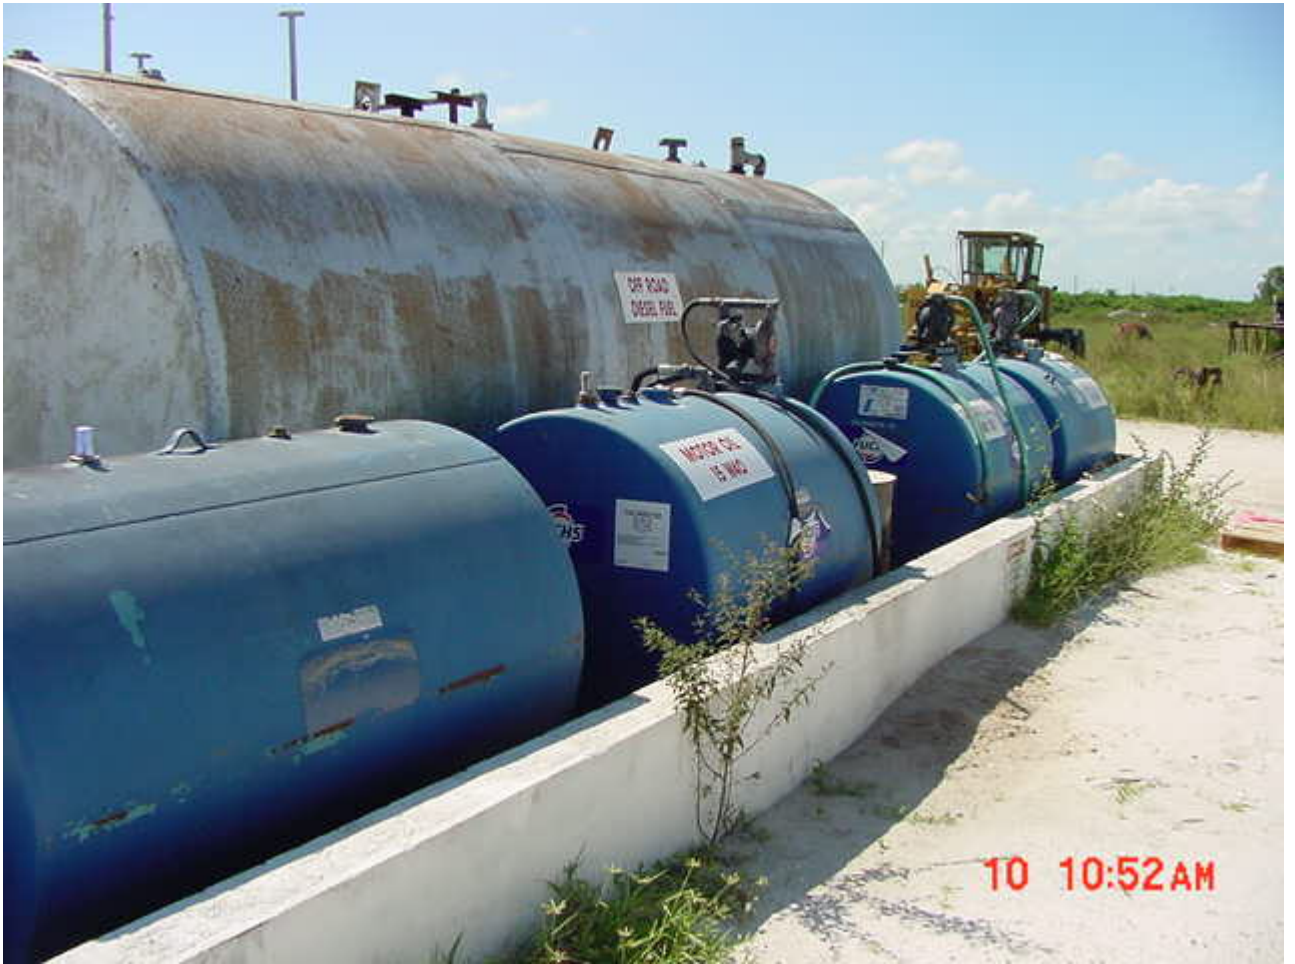
Fueling area along west wall of containment system reveals petroleum discharge.

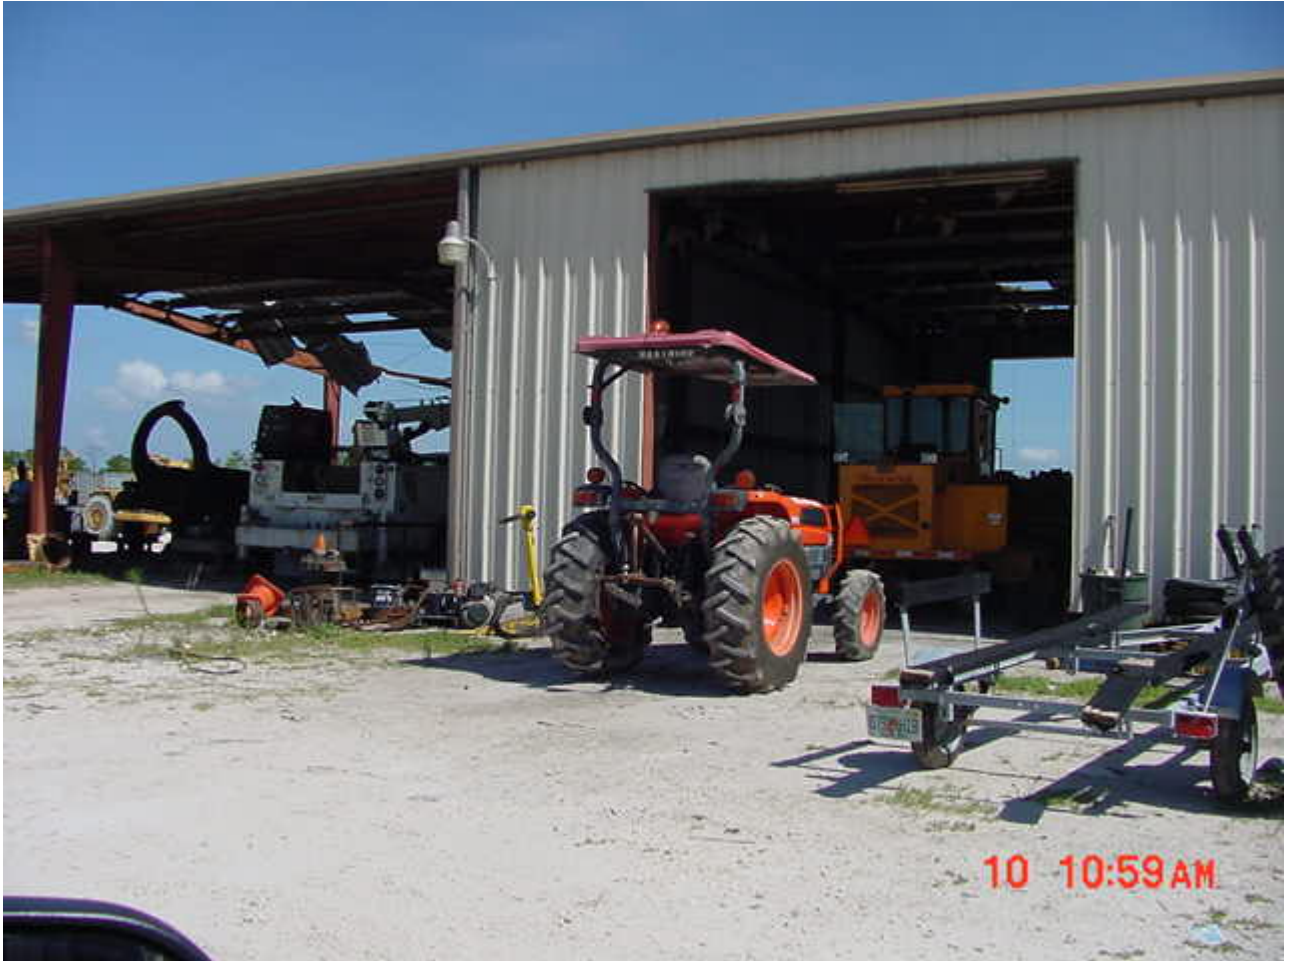
Mechanical repair/maintenance building which was permitted for bonafide agriculture use only is now the main mechanical repair/maintenance facility for Westwind Mines. Building has outside storage of equipment and equipment parts scattered around perimeter of the building.
