Westwind Mines
Corkscrew Road
Follow Up Inspection
08-10-2007(A)

Job: Re-inspect mine for storage containment system of used oil.

Westwind Mines
Corkscrew Road
Follow Up Inspection
8-10-2007 (B)

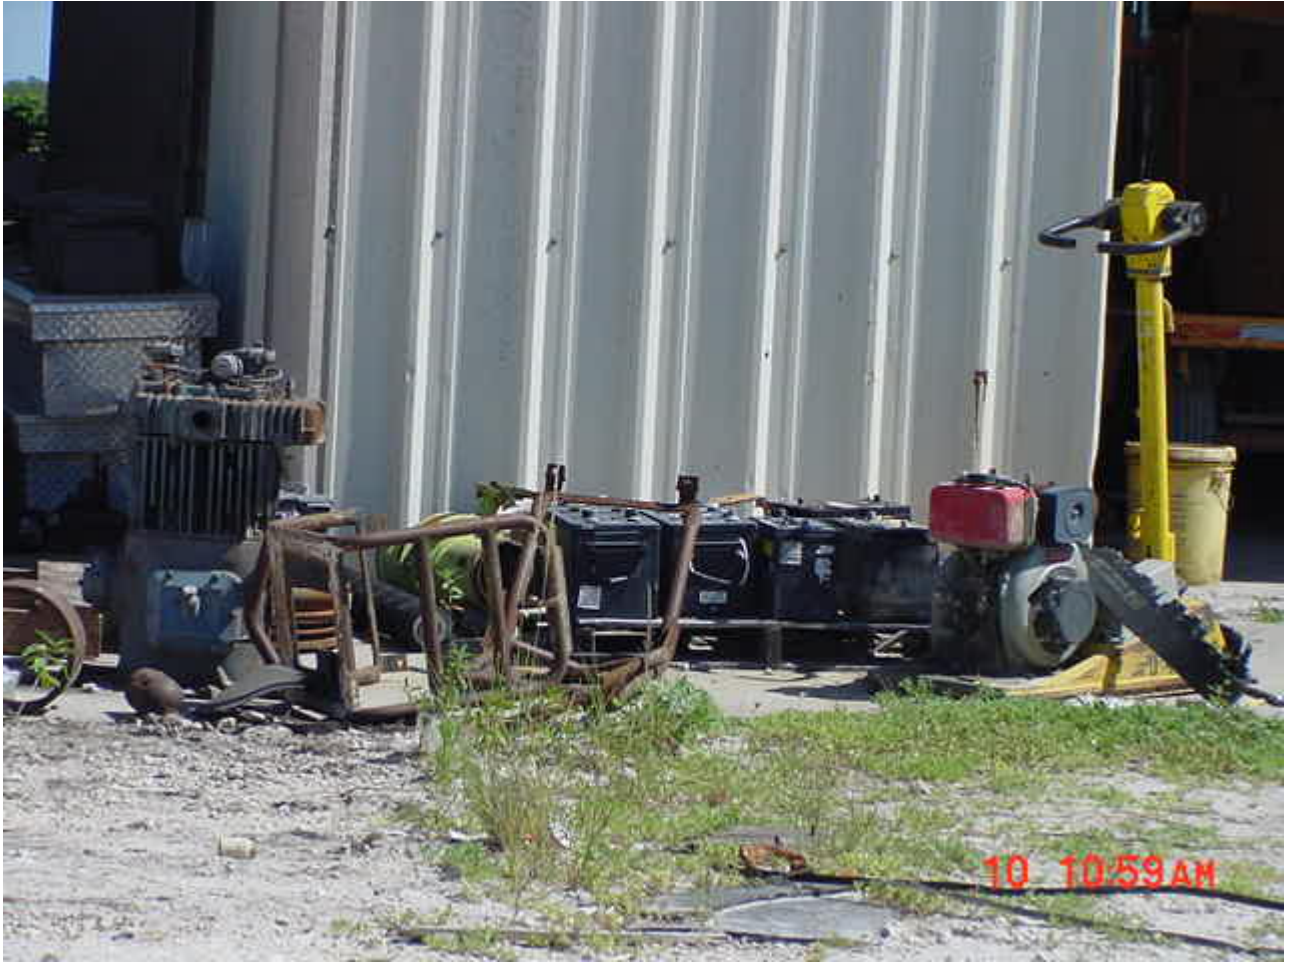
Lead acid equipment batteries stored outside of building within the drip edge of the roof and not within containment to protect from contaminated rainwater runoff. Stained soils in various places along perimeter of building.

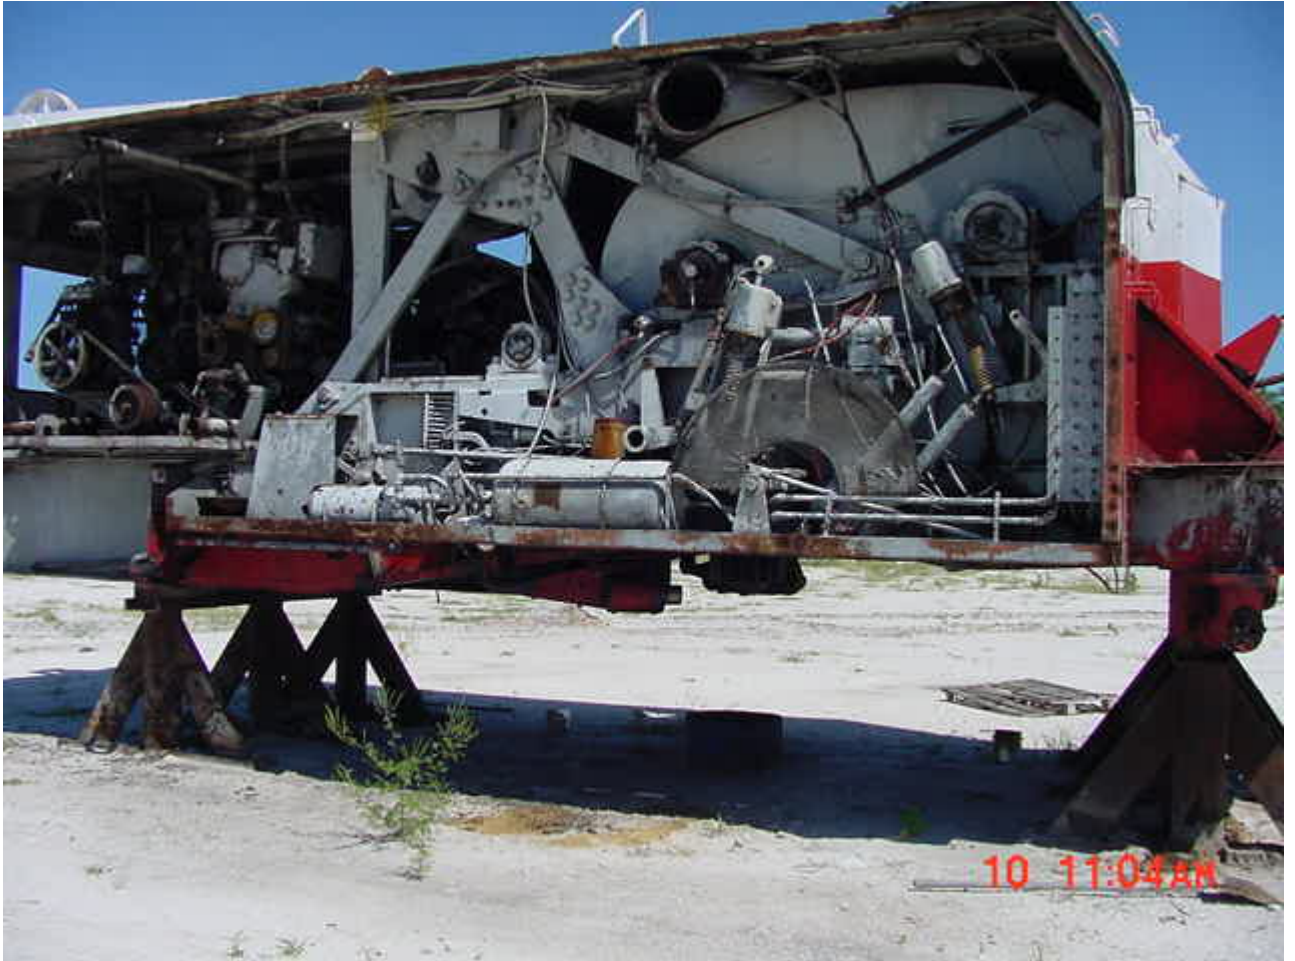
A dragline in pieces with stained soils and a container of petroleum underneath the engine compartment.

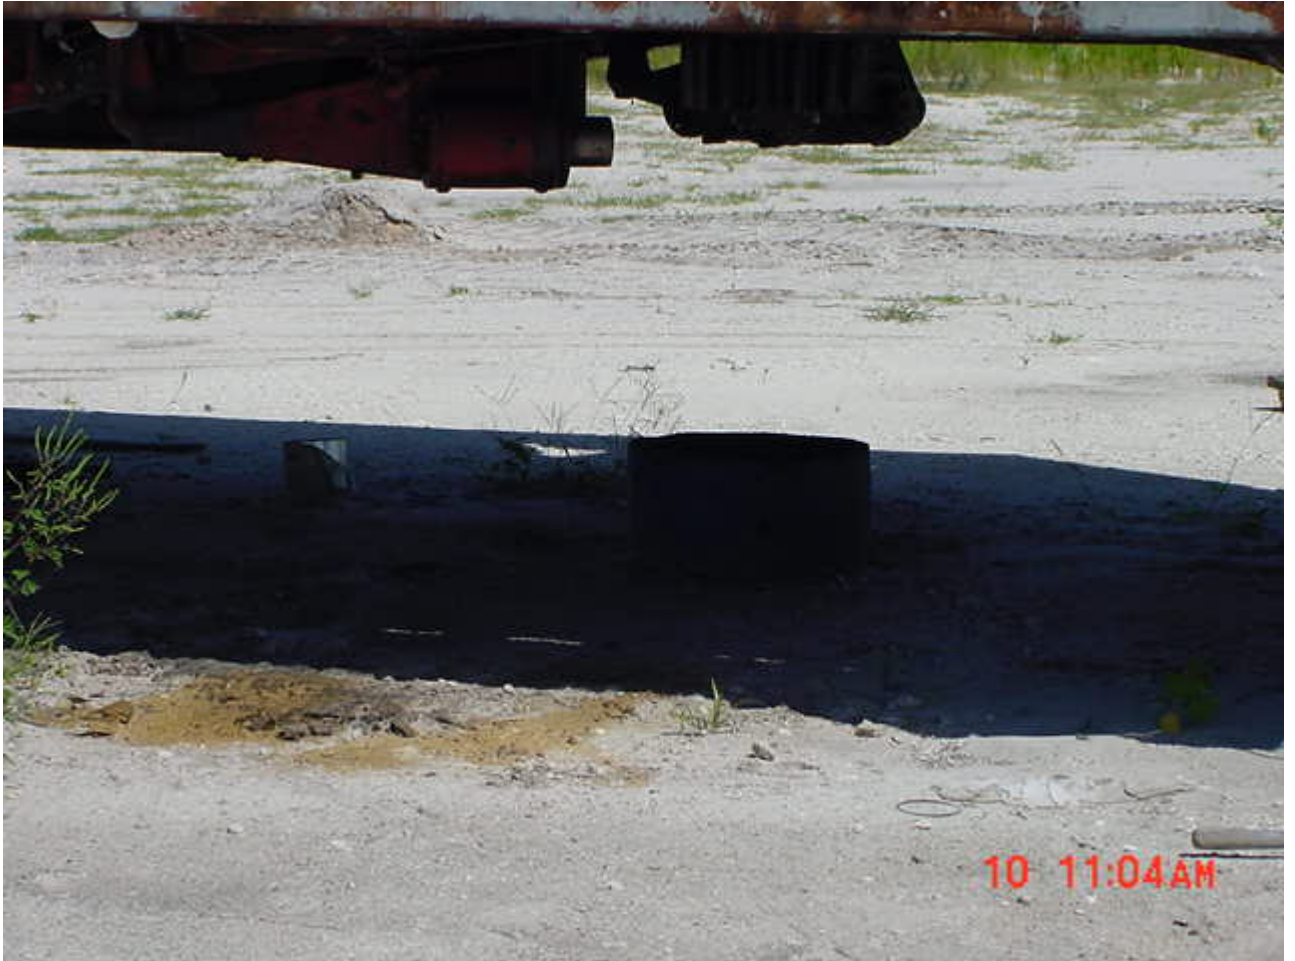
An up close view of contaminated soils and open container of petroleum product underneath the motor section of a dragline.
